Up-armored
HMMWVs...

THE BUZZ ON CARGO SHELL HATCH BRACKETS

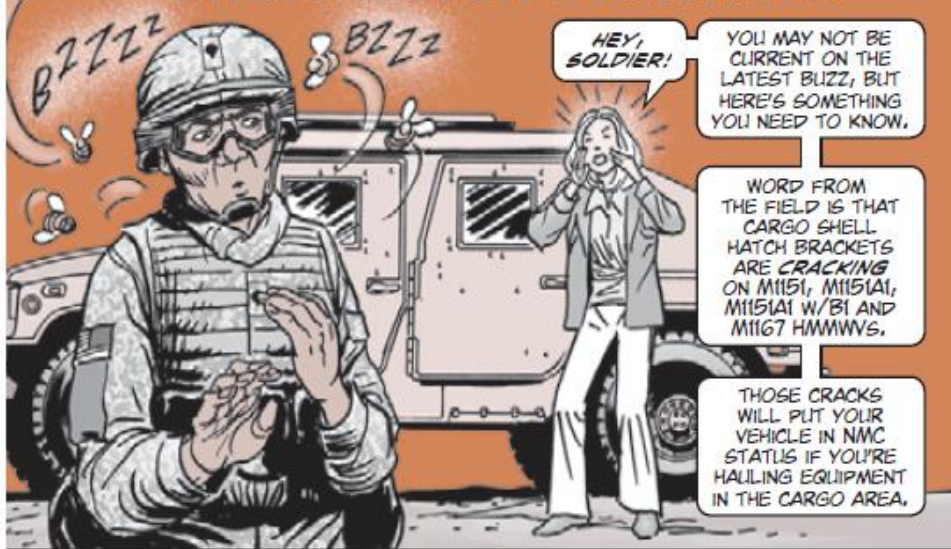
One reason for this failure is that the hatch is opened from the rear position before the forward latch is completely closed to the second detent. When that happens, the added leverage can result in a cracked or failed bracket.

Prevent this problem by reviewing and doing the opening and closing procedures for the cargo shell hatch. That's found in Para 2-32 on Pages 2-96-2-97 of TM 9-2320-387-10 (Oct 97, w/Ch 6, Jun 09).

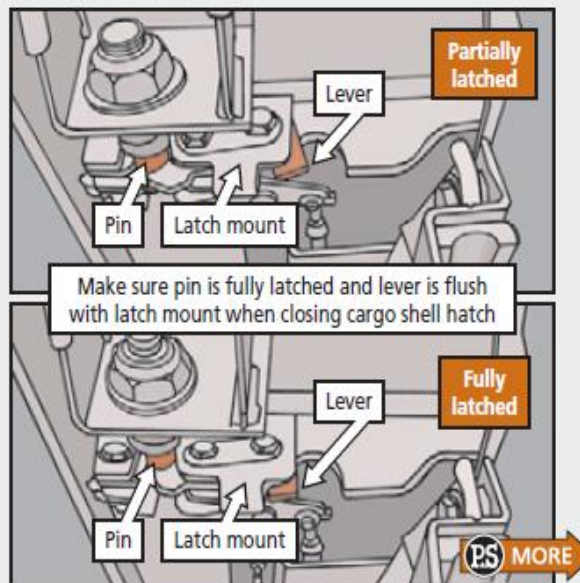
Some units have welded the brackets as a quick fix, but that's *not* an authorized repair. The truck headshed has approved a much stronger bracket with the same fit and function and similar form as the original bracket.

The original bracket's NSNs may bring either a redesigned or an original bracket until the original brackets are used up. That's OK. Just be sure to correctly open and close the cargo shell hatch, no matter which bracket you get. Order these NSNs:

Left-hand - NSN 2590-01-574-8770

Right-hand - NSN 2590-01-574-8782
